Licentiate Thesis in Civil and Architectural Engineering, Building materials

# Cycle paths' degradation processes and surface condition assessment

Licentiate Thesis in Civil and Architectural Engineering, Building materials  
KTH Royal Institute of Technology  
Stockholm, Sweden 2023

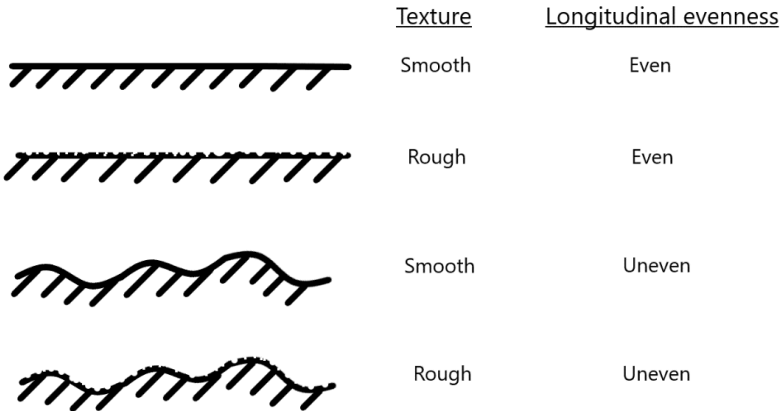
**Figure 1.** A graphic visualization of the difference between smoothness/roughness and evenness/unevenness.

Apart from the asset management aspect of minimizing the degradation of the cycle infrastructure, there is also the user perspective where the cyclists’ traffic safety, level of service and comfort must be considered. This aspect is, in most cases, related to the surface of the cycle path which constitutes the interface between the cyclist and the cycle path. When referring to road surface condition, in this case cycle path surface condition, there are two important terms that are often used: evenness/unevenness and smoothness/roughness. Sometimes these are treated as interchangeable concepts in the literature, but for this thesis they will be applied for different aspects of the surface condition. **Smoothness/roughness** refers to the *texture* of a cycle path surface whereas **evenness/unevenness** refers to the *longitudinal evenness*, as described in **Figure 1**.

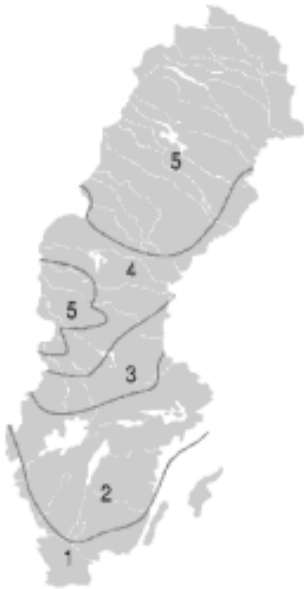
**Figure 5.** Climate zones used for the structural design of roads according to *TRVK Väg* (Trafikverket, 2011).

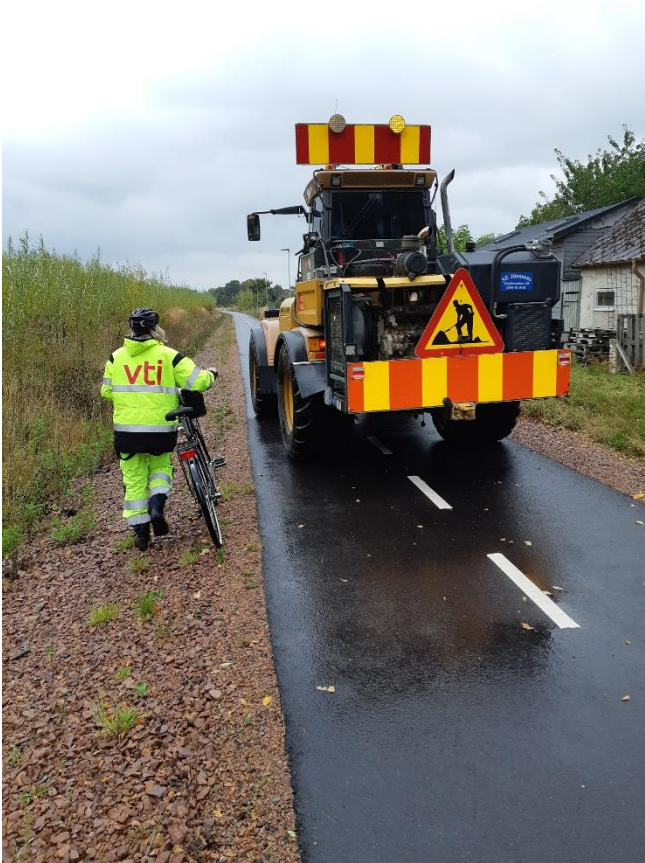
**Figure 7.** Heavy maintenance vehicle transiting a cycle path in Skåne, Sweden. Note the vehicle's wheel span width in relation to the width of the cycle path, and how close to the edge that the wheels are.

A heavy vehicle (**Figure 7**) is defined as a vehicle with a total weight of 3.5 tonnes or more (Trafikverket, 2011). The cycle paths should be designed for a maximum of 8 tonnes of axle-loading weight, according to *TRVK Väg*. This extreme-load limit is important as it could be that just a few passages from a heavier vehicle suffice to break the structure, which is manifested as the frequency of edge cracks and edge deformations on the cycle paths. In Sweden, 23 percent of the cycle path network is estimated to suffer from edge damage (Ekdahl, et al., 2016), and one third of the municipalities state that edge deformation is quite frequent or very frequent on the municipal cycle paths (Larsson, et al., 2022).

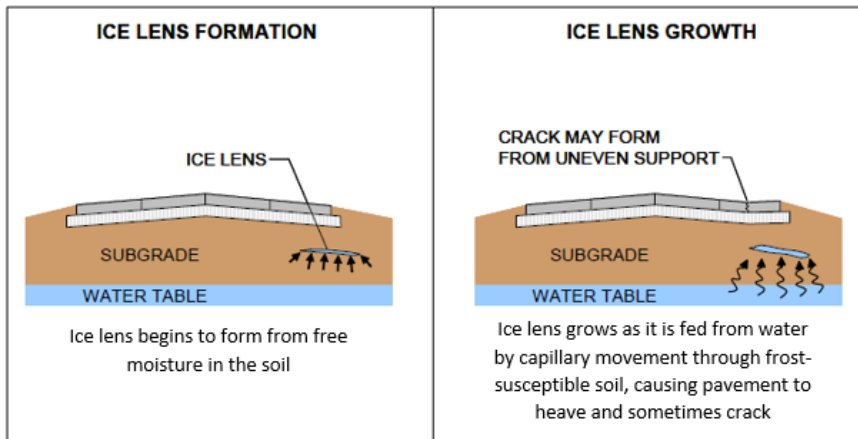
**Figure 9.** The formation of ice lenses causing frost heave in the pavement, which may lead to cracking of the surface (Waalkes, 2003).

amount of snow, the quality of the materials in the subgrade, the temperature and length of the ground frost period, along with the presence of water, determine how big the frost heave will be (Ekdahl, 2019). Frost susceptibility may vary along the road and along the transverse direction of the road, which contributes to the frost heave. In the unbound granular materials (UGM), the presence of salt from the de-icing maintenance or other fine materials can also make frost heave occur in these construction layers, even though UGM materials are not normally frost susceptible due to their aggregate size and air voids (Doré & Zubeck, 2009). As the free moisture in and under the road structure freezes and ice lenses are formed, more water from the surrounding materials is sucked into the structure and this water also freezes and so on (**Figure 9**).

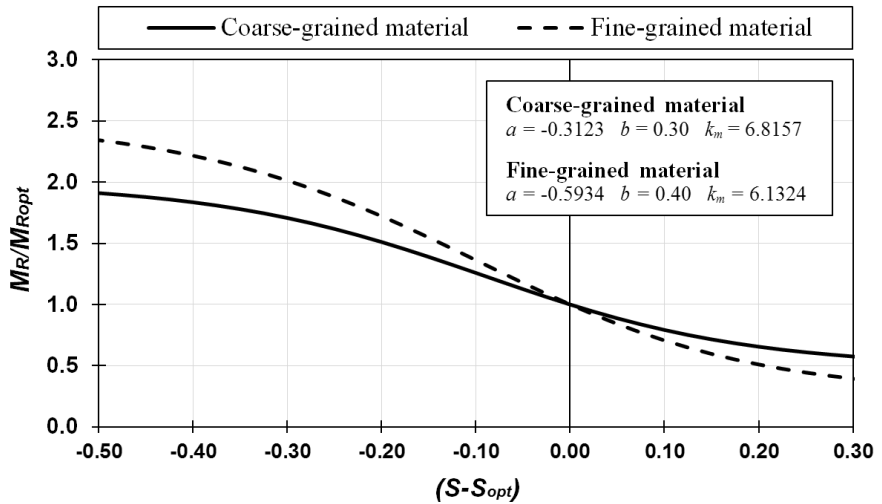
**Figure 11.** The figure shows how the resilient modulus of UGMs is dependent on the level of saturation (Salour & Erlingsson, 2015).  $M_R$  is the resilient modulus at a given degree of saturation and  $M_{Ropt}$  is the resilient modulus at optimum moisture content.  $(S - S_{opt})$  is the variation in degree of saturation.

As described in *section 3.1.3*, it is important to have sufficient runoff from the surface of the cycle path to avoid standing water on the surface (Wallberg, et al., 2010), as water and moisture are involved in a lot of the degradation processes that occur. **Figure 11** shows how the resilient modulus ( $M_R$ ) is related to the moisture content of the UGMs, i.e., the degree of saturation ( $S$ ).

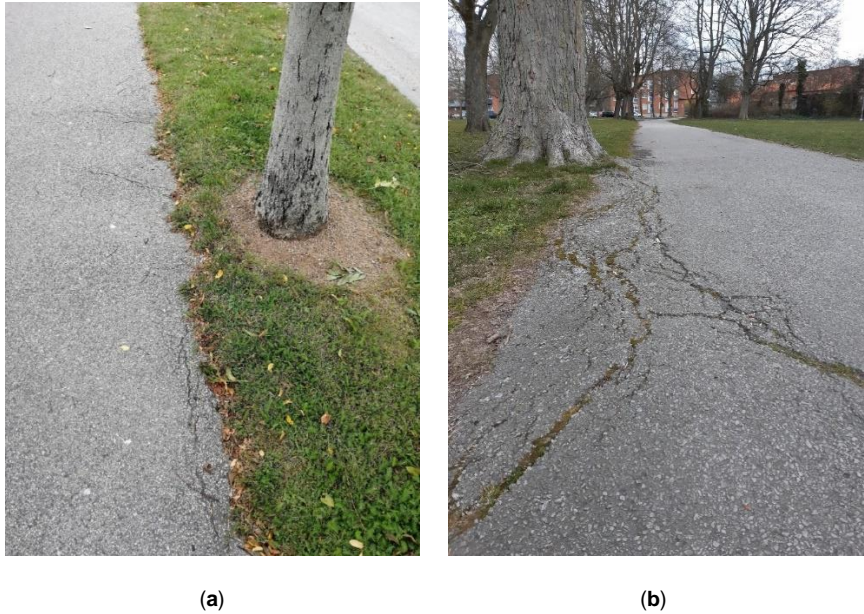
**Figure 12.** (a): Initial cracking of the asphalt concrete due to infiltration of roots from a tree that was placed too close to the edge of the cycle path. (b): Advanced cracking of the asphalt concrete from an old tree beside the cycle path. Grass intrusion of the cracks has occurred.

As the roots expand, the asphalt layers are pressed upwards, presenting a bulge on the surface which cracks when the strain gets too big. Once a crack is formed, it propagates down through the asphalt layer as water from precipitation and air are allowed into the structure. This seems to accelerate the growth of the roots further, in a self-reinforcing process. Thus, the infiltration of roots into the structure causes deterioration of the surface, which leads to conditions for an increase of root infiltration and more cracking, and so on (Imam, 2020). Grass intrusion can also occur because of the water that infiltrates the cracks in the surface, which may lead to a slippery surface. The grass itself can also contribute to push the edges of the crack apart, making the problem more severe (Ekdahl, et al., 2016).

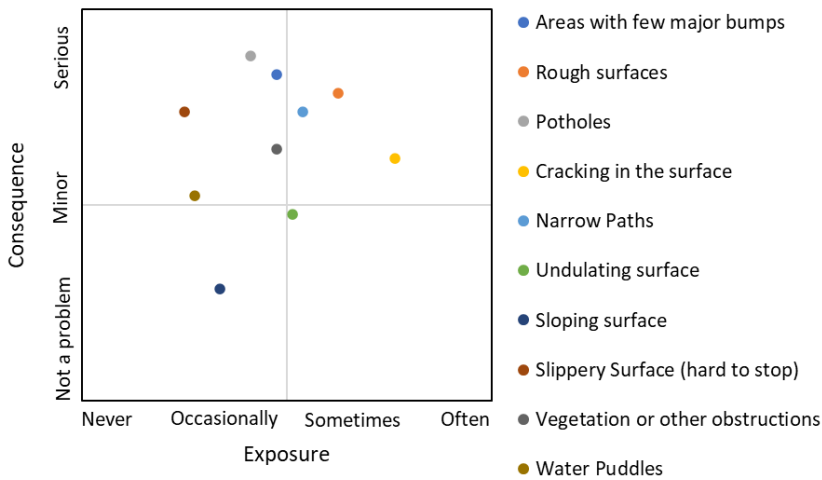
**Figure 16.** The perceived exposure and consequences of 10 different deficiencies on cycle paths, according to participants in the study conducted in Australia by Cairney and King (2003).

The different types of distress on the cycle paths are perceived differently by cyclists. A study by Cairney and King (2003) has shown how the average cyclist perceives the different parameters and how often these parameters occur on the cycle paths in Australia; this is shown in **Figure 16**.

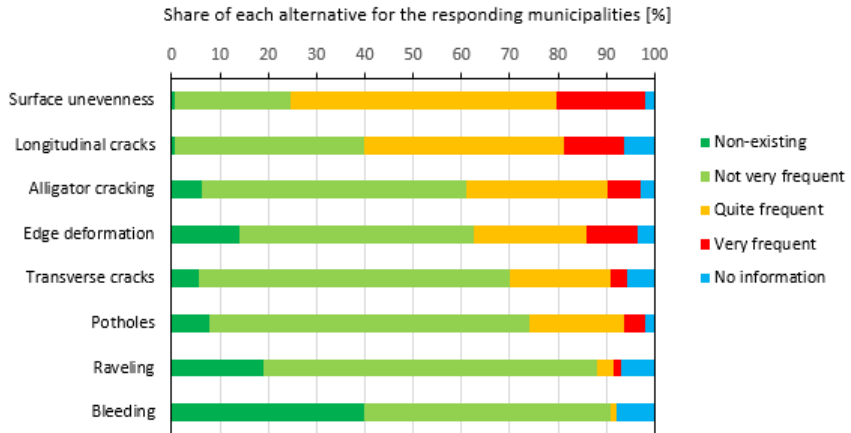
**Figure 19.** The stated frequency of distress by type on the municipal cycle path networks. The response rate varies for the different distress modes ( $n = 141-143$ ) (Larsson, et al., 2022).

These results are largely consistent with the frequency of distresses stated by the municipalities in the survey in Paper A, see **Figure 19**.

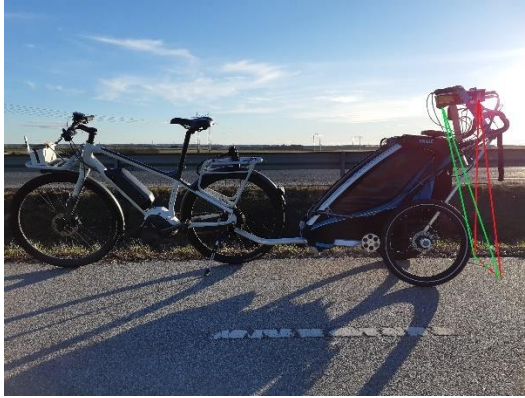
In an effort to develop an objective, data-based condition method, especially designed for cycle paths, work has been done on a Bicycle Measurement Trailer (BMT) at VTI, see **Figure 20**. The system is based on a line laser technique that scans a section of the surface as the bicycle is ridden along the cycle path. Several transverse profiles of surface elevation are collected, which can subsequently be connected into longitudinal profiles by using accelerometer data to remove the movements of the trailer itself.

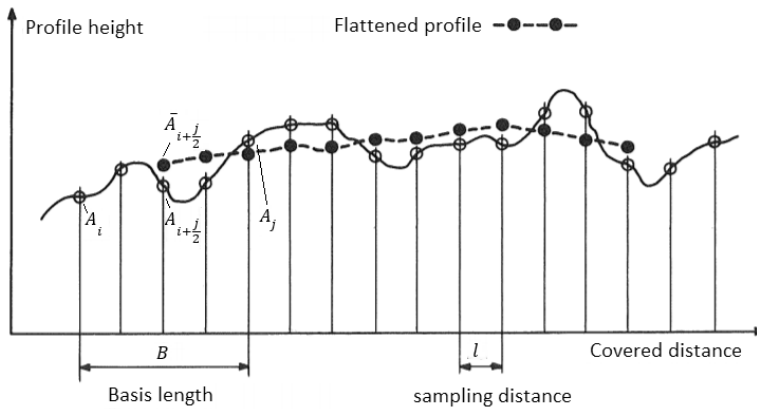
**Figure 21.** The procedure for the creation of a flattened profile based on a sliding average of the measured profile data. The surface between the curves is divided by two and gives the EC for the block length, E. Figure from Gorski (1981, p. 10)

The Evenness Coefficient (EC) is a family of road surface evenness indicators, defined as half of the surface between the measured longitudinal profile and a curve representing the “ideal profile”, which is calculated by a sliding average method (Van Geem & Beaumesnil, 2012), see **Figure 21**.

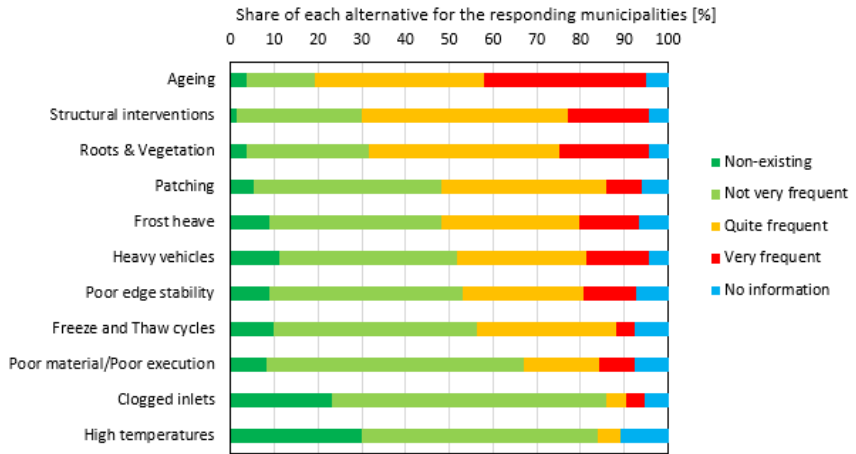
**Figure 22.** Stated causes of distress on the municipal cycle path network. The response rate varies for the different distress causes (n = 133–136).

The survey showed that the most common stated distress mode found on the Swedish municipal cycle paths is surface unevenness, followed by longitudinal cracks and alligator cracking (**Figure 19**). The most frequently stated causes for the distress are ageing, structural interventions, and roots and vegetation, see **Figure 22**. For some of the distress modes, the difference in frequency varies according to temperature, e.g., distress from roots and vegetation are stated as more common in the milder climate of southern Sweden, whereas distress from frost heave and freeze and thaw cycles are more common in the north of Sweden, where the climate is colder.
