Doctoral Thesis in Civil and Architectural Engineering

Structural design, degradation and condition assessment of cycle paths

MARTIN LARSSON

KTH ROYAL INSTITUTE OF TECHNOLOGY

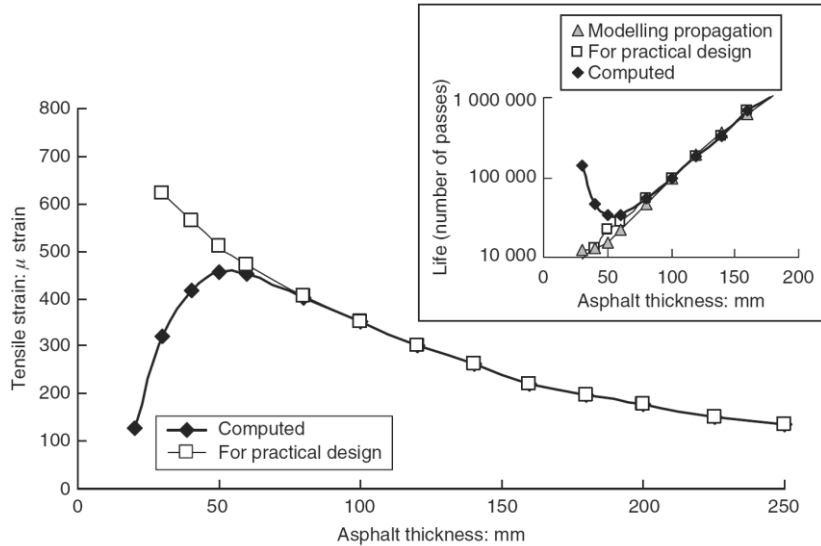
The “modelling propagation” data points—which seem to fit quite well with the “For practical design” extrapolated values—are based on a crack-propagation prediction model.

Figure 6. Adaption of an analytical design calculation procedure for thin asphalt, as presented by Thom (2014).

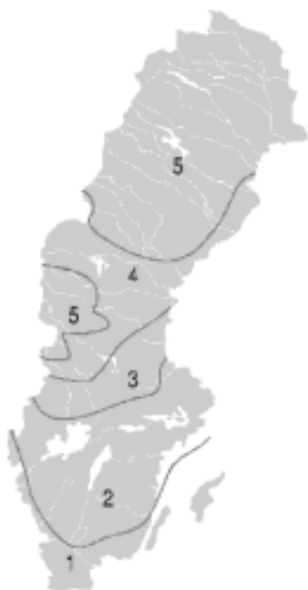
Figure 7. Climate zones used for the structural design of roads, according to *TRVK Väg* (TRV, 2011a).

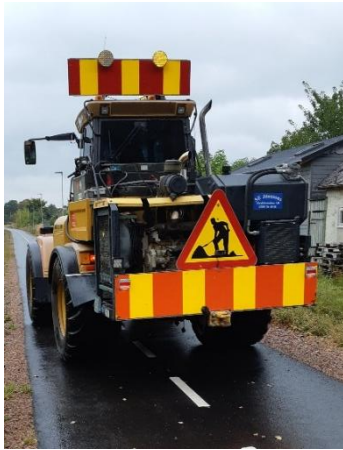
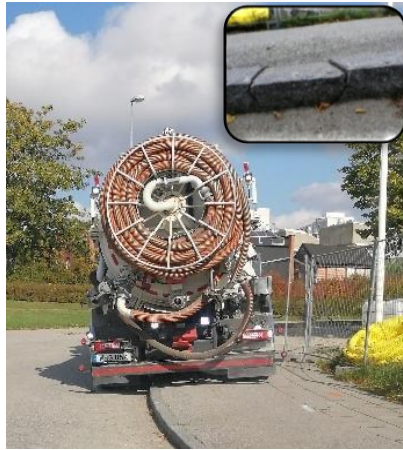
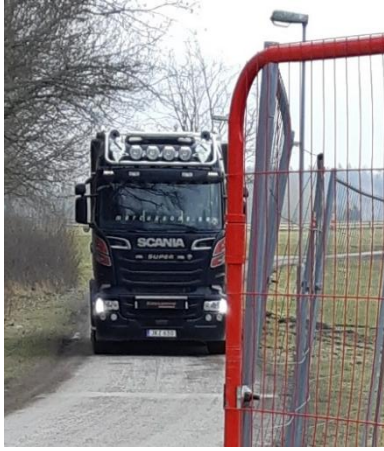
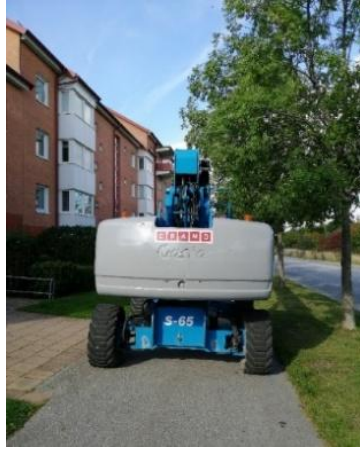
Figure 10. (a-d) Heavy maintenance vehicles transiting cycle paths in the south of Sweden. The track width of the vehicles in relation to the width of the cycle path places them very close to the edges. The cycle path in (b) ended up with a cracked kerbstone while the photo was taken (small, inserted image).

A heavy vehicle is defined as a vehicle with a total weight of 3.5 tonnes or more (TRV, 2011a). As mentioned, the cycle paths should be designed for an extreme load of 8 tonnes of axle-load weight distributed over a surface of 200×200 mm, according to *TRVK Väg*. This extreme-load limit is important as it could be that just a few passages from a heavier vehicle suffice to break the structure, which is manifested as the frequency of edge cracks and edge deformations on the cycle paths. In Sweden, 23% of the cycle path network is estimated to suffer from edge damage (Ekdahl, et al., 2016), and one third of the municipalities state that edge deformation is quite frequent or very frequent on the municipal cycle paths (Larsson, et al., 2022). The speed of the heavy vehicles that transit the cycle paths is often low and sometimes the vehicles are even stopped, due to the purpose of their presence. They could be operational- and maintenance vehicles (**Figure 10a**), e.g., snow ploughing, flushing of water and sewage pipes (**Figure 10b**), or they could be other heavy vehicles that transit the cycle paths, such as lorries bringing construction materials to construction sites (**Figure 10c**) or boom lifts to perform maintenance of adjacent buildings (**Figure 10d**).

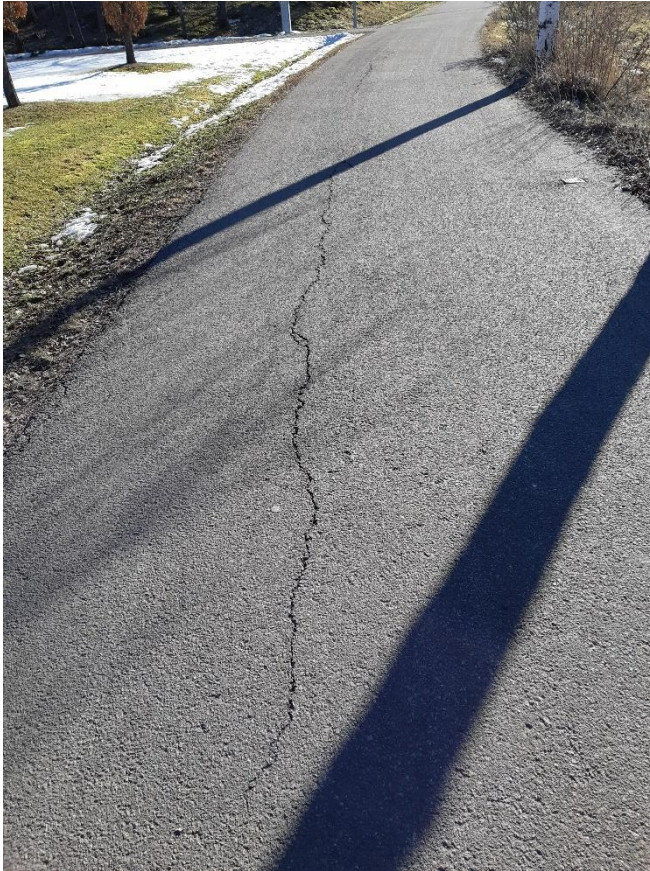
(Chen, 2009). The frost heave normally occurs as wide, deep, longitudinal cracks. On cycle paths (<4 m width) it is common to find them in the middle of the road (Niska, 2011). In roads with thin surfacing, like cycle paths, additional lateral cracks or alligator cracking could occur in connection to the frost-heave crack. **Figure 13** presents a low-severity frost-heave crack.

Figure 13. Frost heave, in the form of a longitudinal crack close to the centre line of the cycle path.

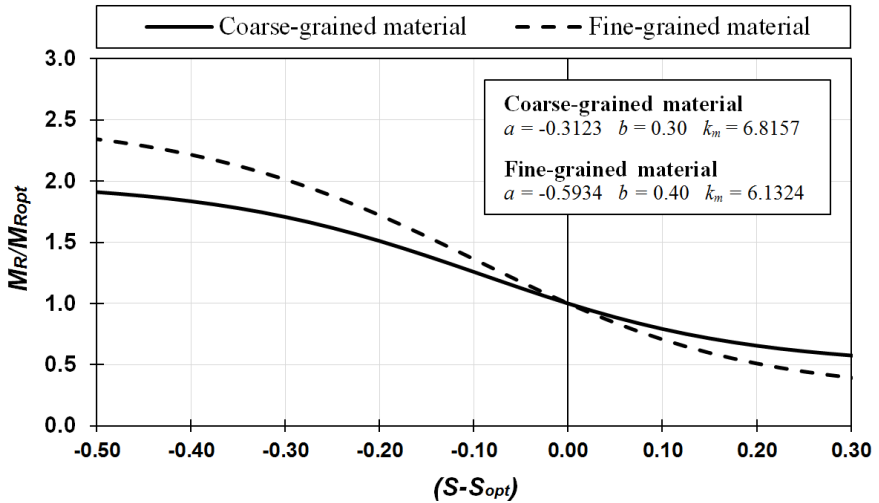
Figure 15. The M_r of UGMs is dependent on the level of saturation (Salour & Erlingsson, 2015). M_R is the resilient modulus at a given degree of saturation and M_{Ropt} is the resilient modulus at optimum moisture content. $(S-S_{opt})$ is the variation in degree of saturation.

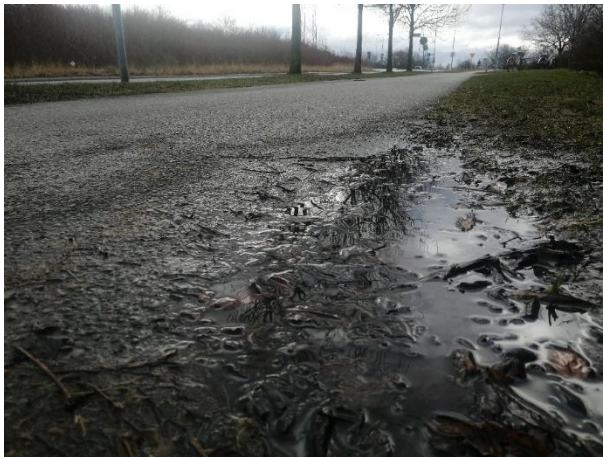
Another problem that is more common on cycle paths, as compared to roads, is the lack of ditches. The cycle paths are often constructed at the same level as the adjacent ground and are normally not built with shoulders. The edge of the path is therefore in many cases located directly beside the adjacent grass- or soil surface, which sometimes does not permit sufficient run-off, as demonstrated in **Figure 16**.

Figure 16. The lack of ditches and shoulders, in combination with deposited organic material—leaves in this case—results in standing water along the edge of the cycle path.

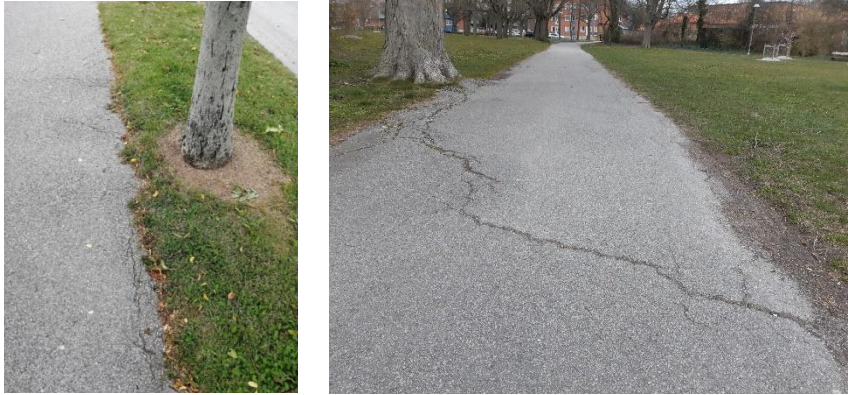
Figure 17. To the left: Initial cracking of the AC due to infiltration of roots from a tree that was placed too close to the edge of the cycle path. To the right: Diagonal crack that spans the whole width of the cycle path.

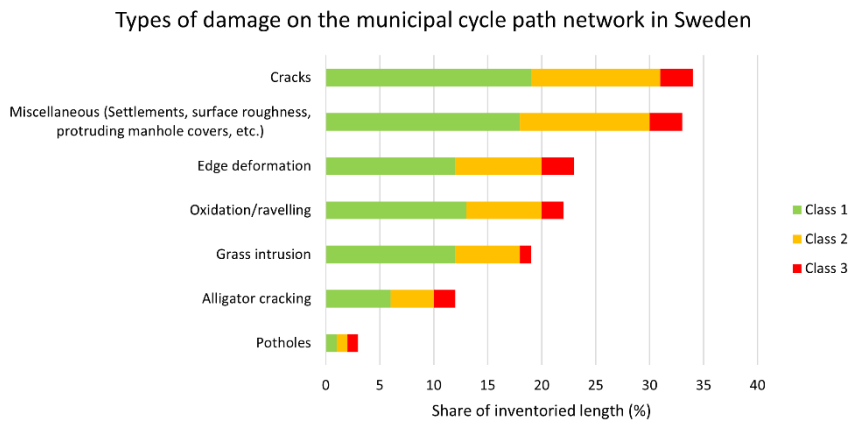
Figure 22. The distribution of road damage, by type and severity, on the Swedish municipal cycle path network, according to (Ekdahl, et al., 2016).

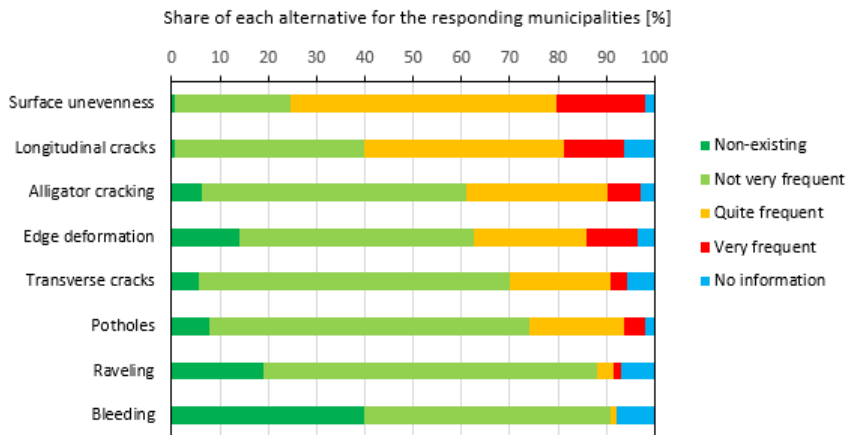
These results are largely consistent with the frequency of distresses stated by the municipalities in the survey in Paper A, see **Figure 24**.

Figure 24. The stated frequency of distress by type on the municipal cycle path networks. The response rate varies for the different distress modes (n = 141–143) (Larsson, et al., 2022).

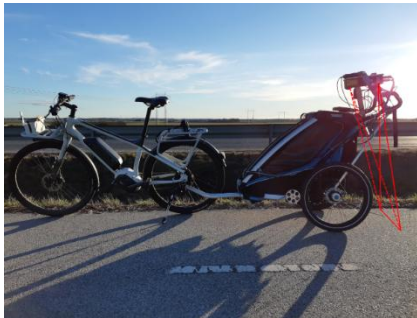
In an effort to have an objective, data-based condition assessment method, especially designed for cycle paths, a Bicycle Measurement Trailer (BMT) has been developed at VTI, see **Figure 25**. The system is based on a line laser technique that scans a section of the surface as the bicycle is ridden along the cycle path. Several transverse profiles of surface elevation are collected, which can subsequently be connected into longitudinal profiles by using accelerometer data to remove the movements of the trailer itself.

Figure 25. The BMT. Solid and dashed red lines indicate laser emissions and reflections to determine the profile height. Below, a description of the components of the BMT.

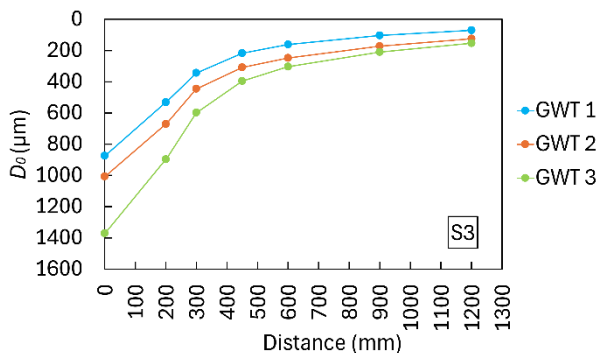
The FWD measurements confirmed that the load-bearing capacity is reduced as the GWT is raised. **Figure 33** presents a plot of the deflection bowl at the different GWT scenarios close to the edge for one of the investigated structures. From the figure, the first rise in GWT offsets the deflection bowl curve parallelly but does not change its inclination, indicating that the loss of load-bearing capacity is attributable to the increased moisture content in the SG but the UGMs are not affected by this rise. For the second rise, however, the geophones closest to the loading centre are more affected with larger deflections, whereas the geophone farthest from the loading centre shows only a marginal increase in deflection. This indicates that the UGMs are now responding to an increased moisture content. Noticeably there is a 65% increase in deflections between the completely drained GWT 1 scenario and the undrained GWT 3 scenario.

Figure 33. Deflection bowls for the different GWT scenarios, as measured close to the edge on structure 3.
