DEGREE PROJECT IN LIGHTWEIGHT STRUCTURES,
SECOND CYCLE, 30 CREDITS
STOCKHOLM, SWEDEN 2026

Lessons Learned from Damage History of a Corvette

KTH Master Thesis Report

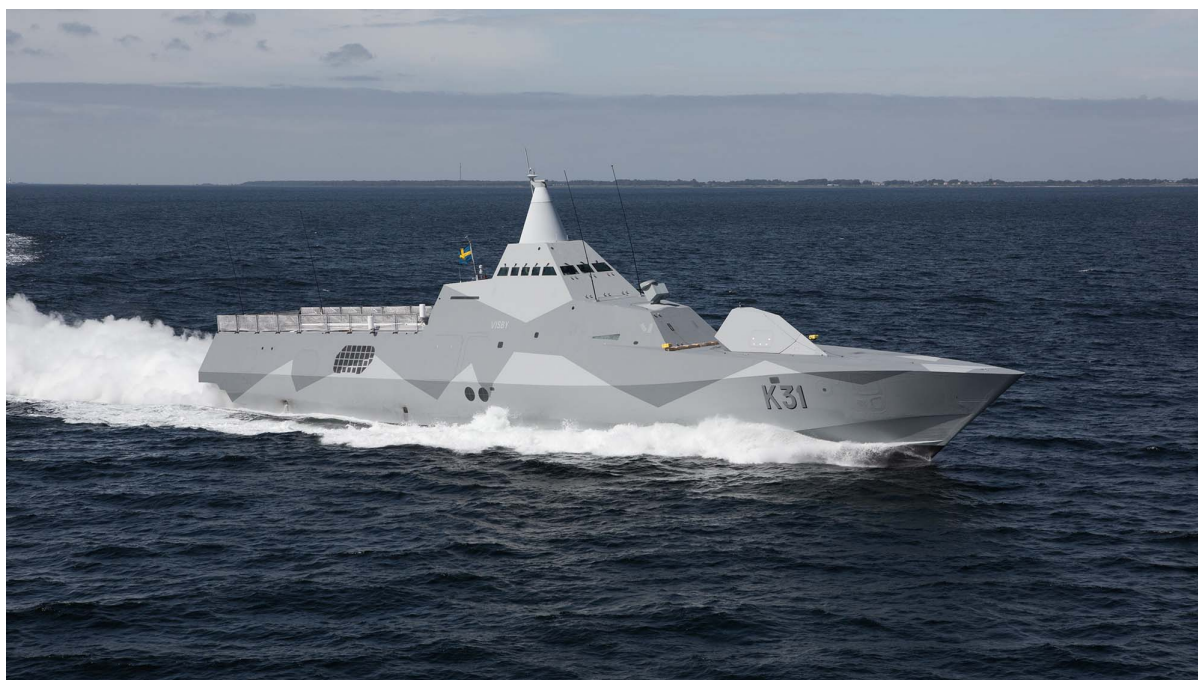
Figure 1.1.1: HSwMS Visby (K31) in use at sea [4].

HSwMS Visby (K31) was the first corvette developed by the Swedish Defence Materials Administration (FMV) for use at sea in the Visby-class and can be seen in Figure 1.1.1. Construction began in 1996 by Kockums AB (now Saab Kockums AB) and the official launch was in 2000. In 2002, the ship was delivered to FMV to be fitted with weapons and other combat systems. Since then, a total of five corvettes have been built in the Visby-class. These include HSwMS Helsingborg (K32), HSwMS Härnösand (K33), HSwMS Nyköping (K34) and HSwMS Karlstad (K35), all of which were launched in the years 2003-2006. A sixth ship in the Visby-class, HSwMS Uddevalla (K36), was planned but ultimately canceled in 2001 [1]. In 2009, HSwMS Helsingborg and HSwMS Härnösand were delivered to the Swedish Navy as the first of their class, fully equipped with weapon systems [2], though in version 4, which lacked features such as equipment for surface combat and mine clearance as well as a helicopter platform [3]. Every ship is now upgraded to version 5, with plans for each to be half-life modified to version 6, extending their longevity as ships in service beyond 2040 [4]. Important milestones for each ship can be seen in Table 1.1.1 and important characteristics of the corvette can be seen in Table 1.1.2.

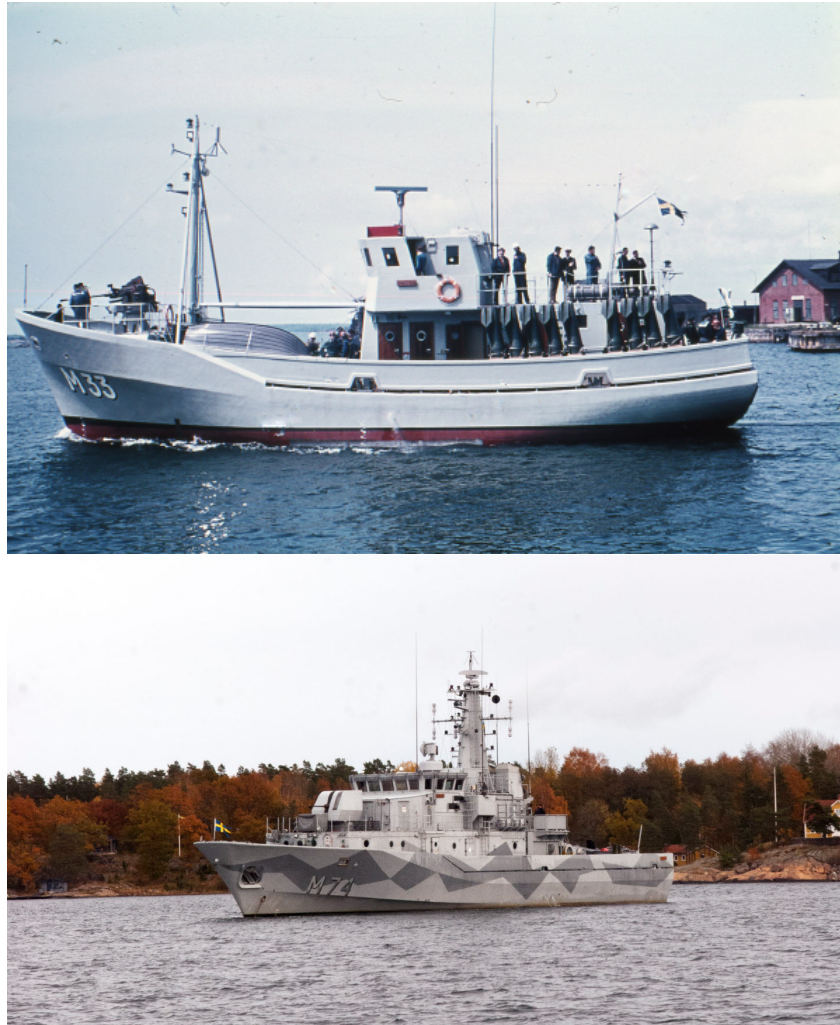
Figure 1.1.2: Early sandwich ships: HSwMS Viksten [10] (above) and HSwMS Kullen, a Koster-class ship [11] (below).

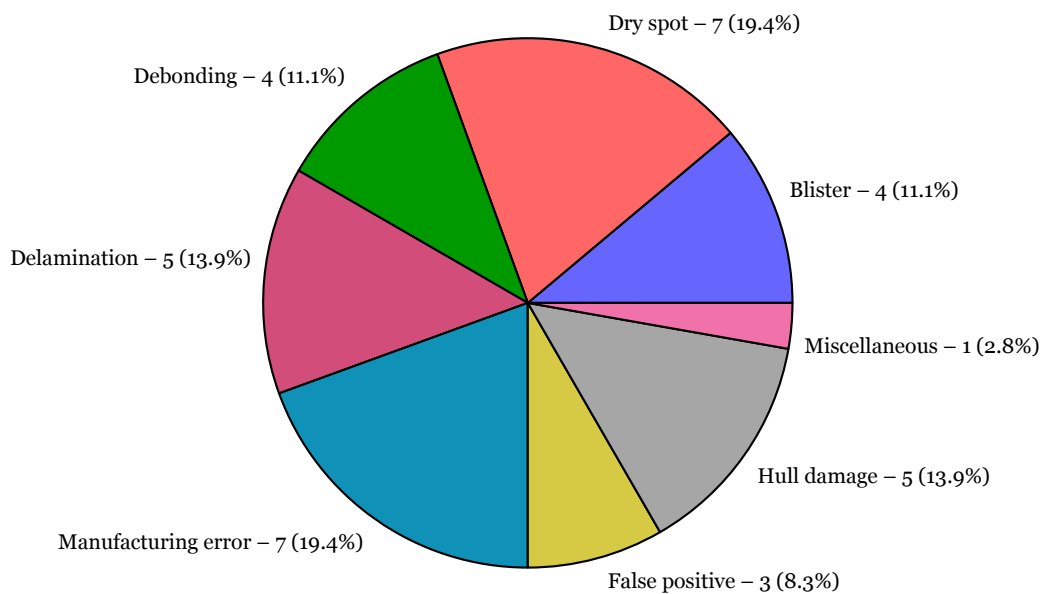
Figure 5.1.2: Distribution of defect types in damage history of HSwMS Helsingborg (K32) (total number of cases: 36).

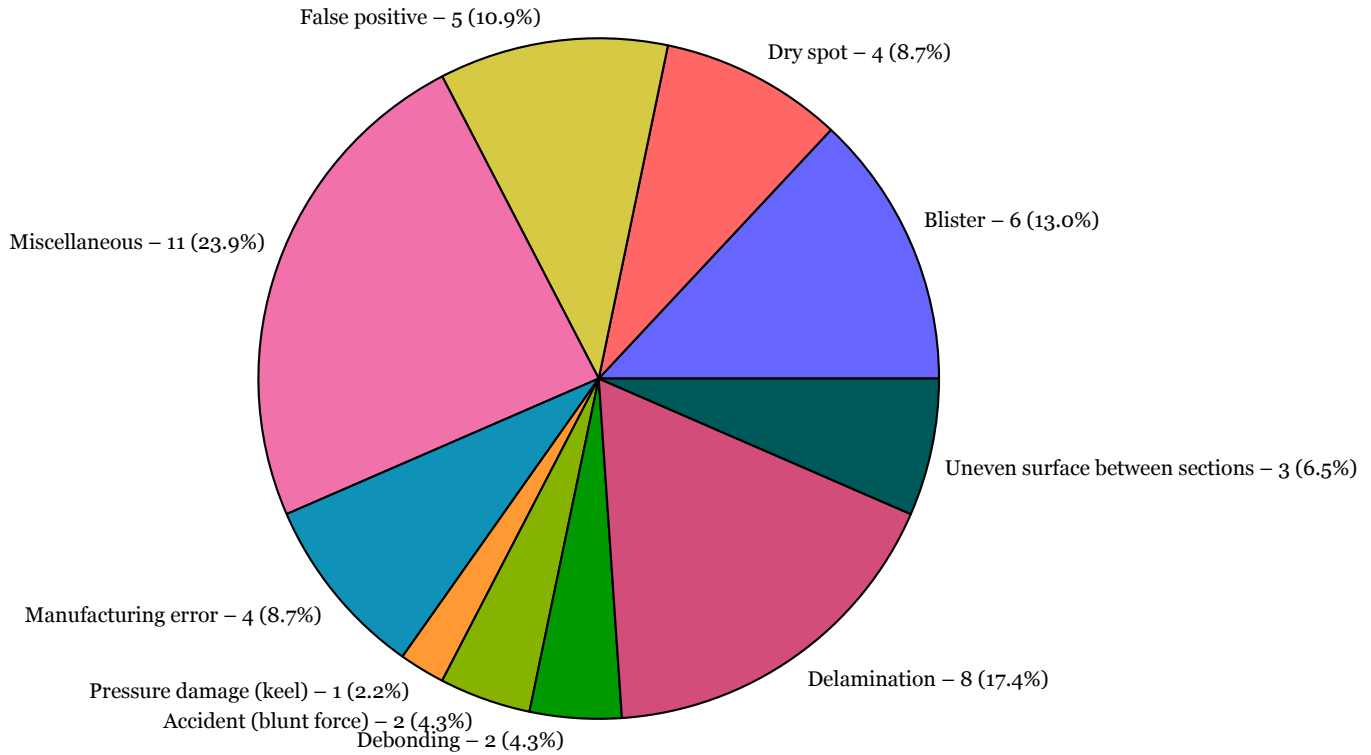
Figure 5.1.3: Distribution of defect types in damage history of HSwMS Härnösand (K33) (total number of cases: 46).
